UPDATE ON THE RECLAMATION OF THE YANKEE GIRL TAILINGS SITE, YMIR, B.C.

M. Tinholt, P.Eng.¹, C. Bullock¹, D. Schneider¹
G. Stewart, P. Geo² and G. Sinnett, P.Geo²

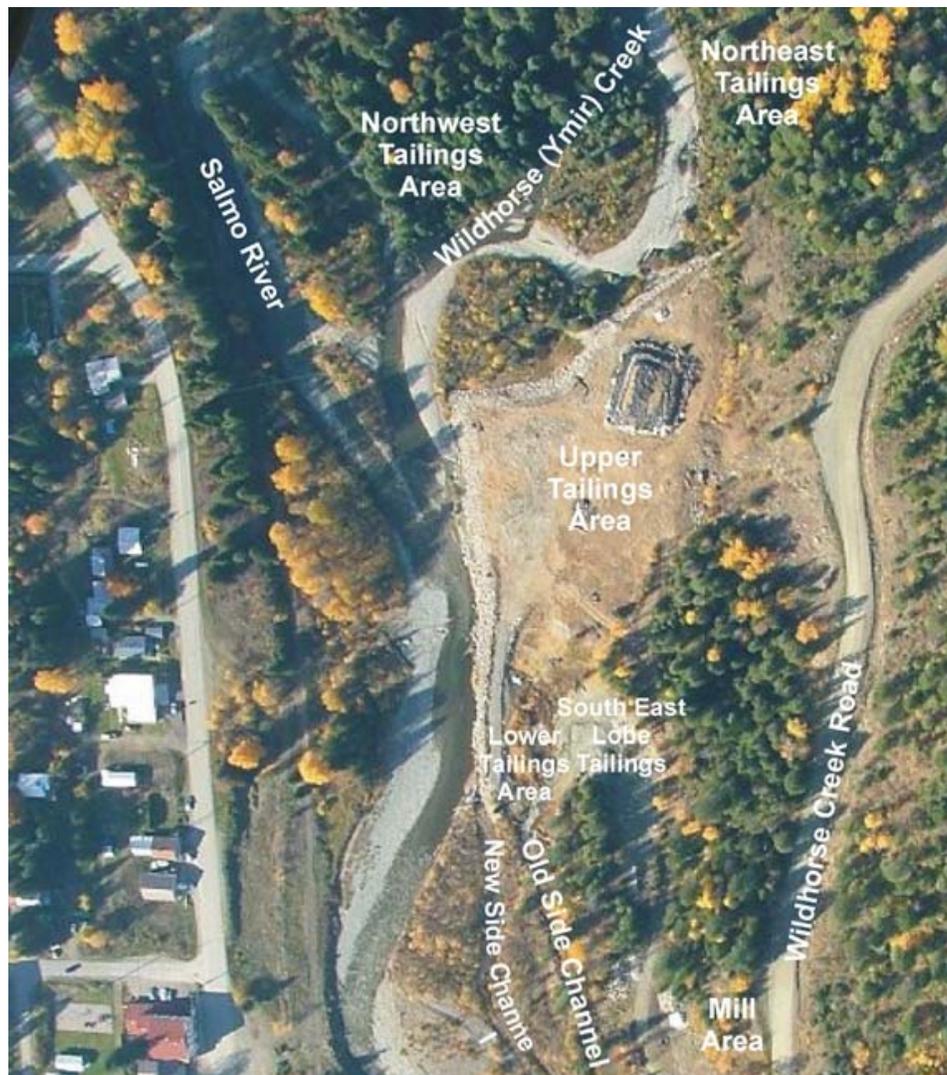
Photograph 1: Site Overview

The subject site is approximately 6 ha area in size, located east of the Salmo River, and west of Wild Horse Creek Road near Ymir, BC. Photograph 1 illustrates the key features of the site, which includes the following:

- Upper Tailings Area;
- Lower Tailings Area;
- Southeast Lobe Tailings Area;
- Northwest Tailings Area;
- Northeast Tailings Area;
- Old Mill Area;
- Old Side Channel; and
- New Side Channel.

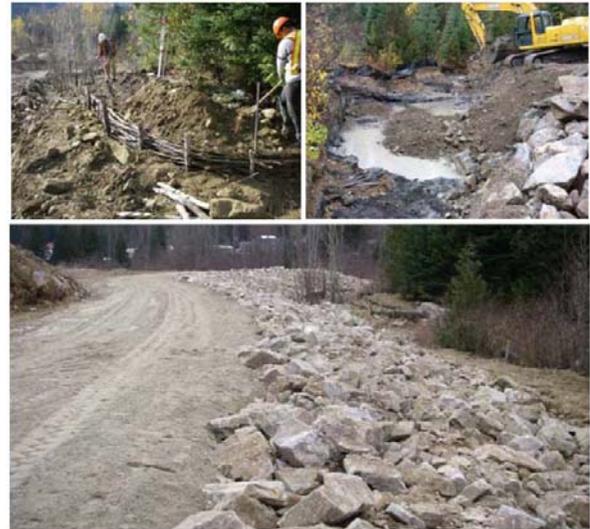
Installation of bioengineering protection (upper left); Removal of tailings outside original barrier (upper right); and completed barrier (bottom)

Residual tailings that were adjacent to Wildhorse (Ymir) Creek at the toe of the erosion barrier were excavated. The overall height of the erosion barrier was increased to provide 1:200 year flood event protection. Climate change and pine beetle implications were design considerations. Live tree cuttings and rooted trees salvaged from other areas of the site were placed at the toe of the erosion barrier to increase erosion protection and enhance ecological habitat.

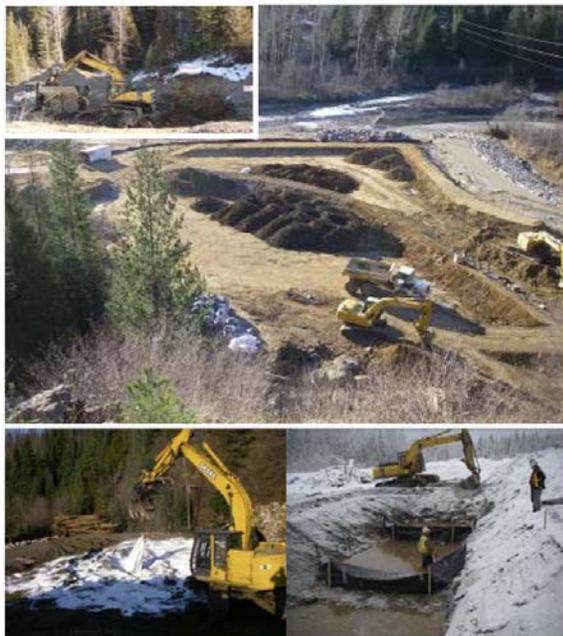
Excavation of tailings (upper left); Upper tailings repository (upper); lime addition (lower left); sedimentation pond (lower right)

Approximately 14,000 cubic meters of tailings and metals contaminated soil was excavated from the former Mill area and Lower Tailings areas. The excavated soil was consolidated in a repository constructed on the Upper Tailings area. Lime was mixed into the tailings to neutralize their acidity. Drainage channels and a sedimentation pond were constructed to collect surface water and runoff until the final cover was placed on the repository in 2008. The excavated areas were backfilled with clean soil in preparation for final site restoration.

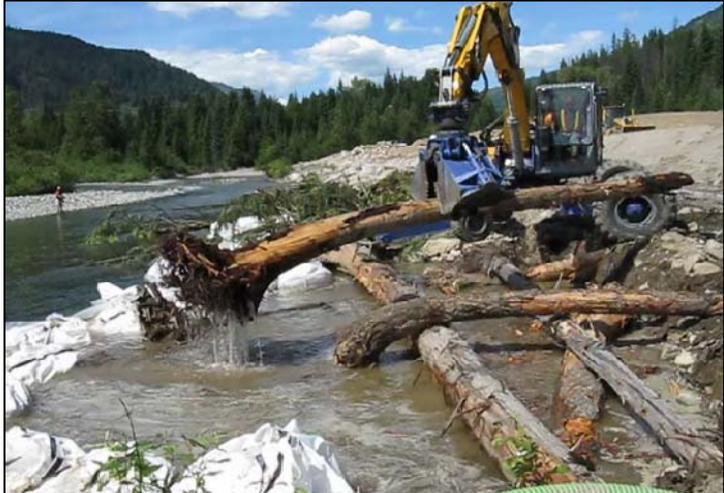
Installation of bio-engineering structures using Spyder Hoe.

A portion of the Salmo River erosion barrier was re-aligned to increase the channel's flood carrying capacity. Bioengineering features were installed for erosion protection and to increase fish habitat, and the disturbed riparian areas were vegetated. The protection level of erosion barriers on Ymir Creek and Salmo River was increased to withstand a 1 in 200 year flood event.

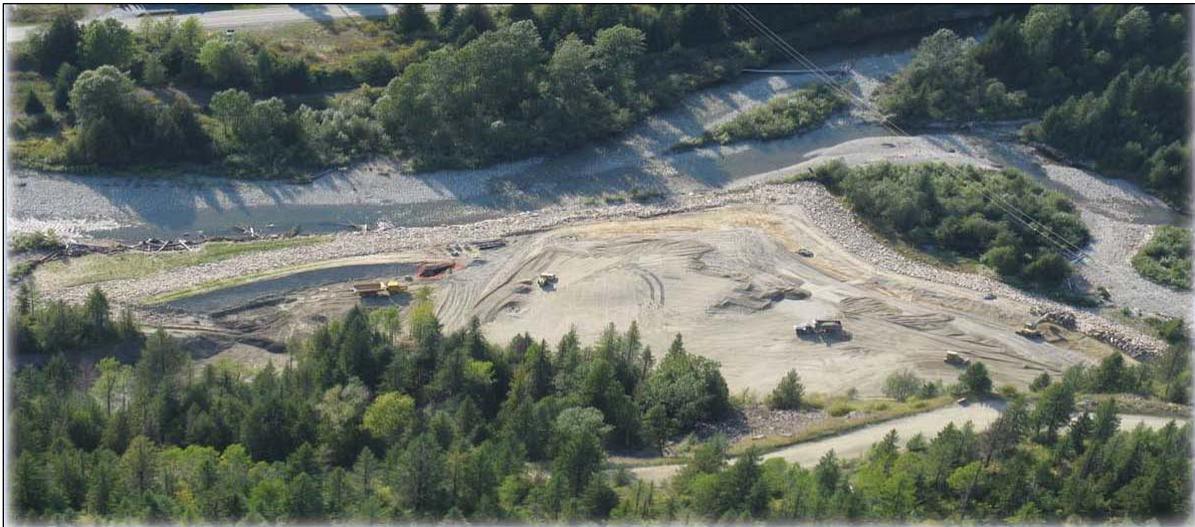
Aerial view of the site during 2008 construction activities.

An engineered cover was placed over the Upper Tailings Area repository. The cover material included a bentonite clay amended layer and a 1 m thick protective cover soil layer. The repository was shaped into an amphitheatre for future community use. Tree islands were incorporated into the cover to mimic a “park-like” setting. A passive treatment system (i.e., engineered wetland bioreactor), which utilized composted pulp mill residuals as an organic substrate, was constructed to polish residual groundwater seepage.

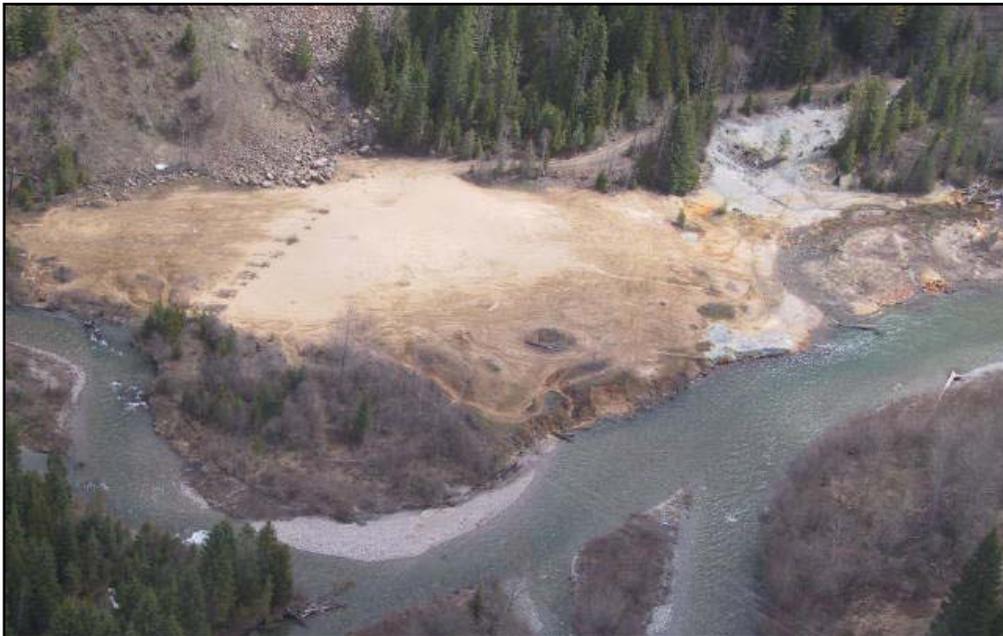
Yankee Girl Tailings in 2004 prior to remediation.

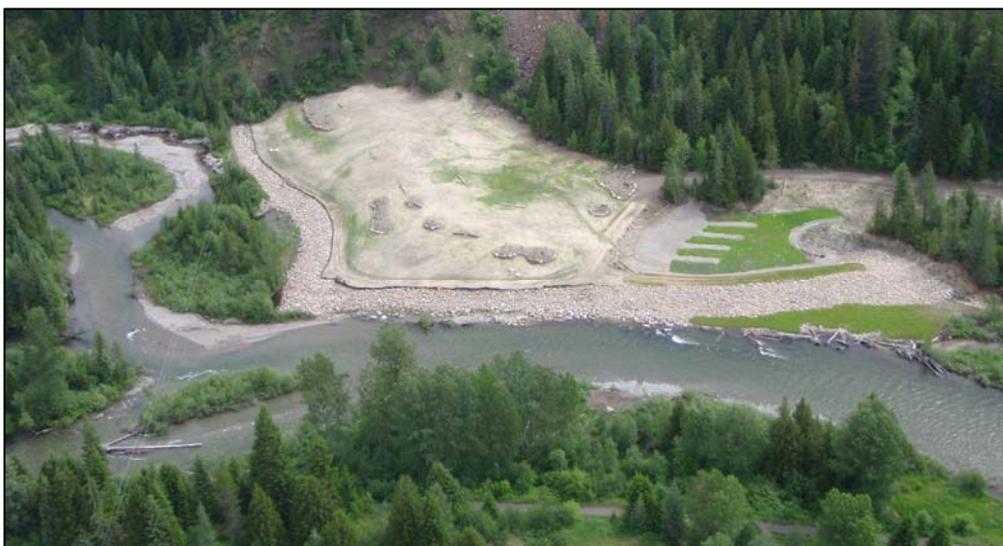
Yankee Girl Tailings in 2009 following remediation.

Remediation work at the Yankee Girl Tailings site has transformed an industrial site to park land for use by the local community. Risks to human health and the environment have been mitigated. Ongoing monitoring and maintenance will be required to confirm the success of the project.

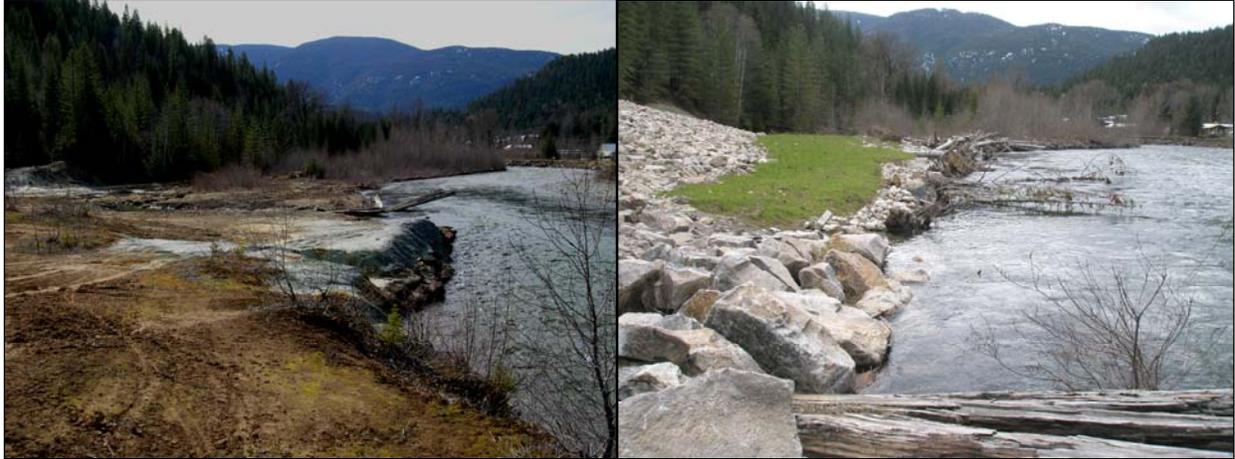
Lower Tailings Area before (left) and after (right) remediation.

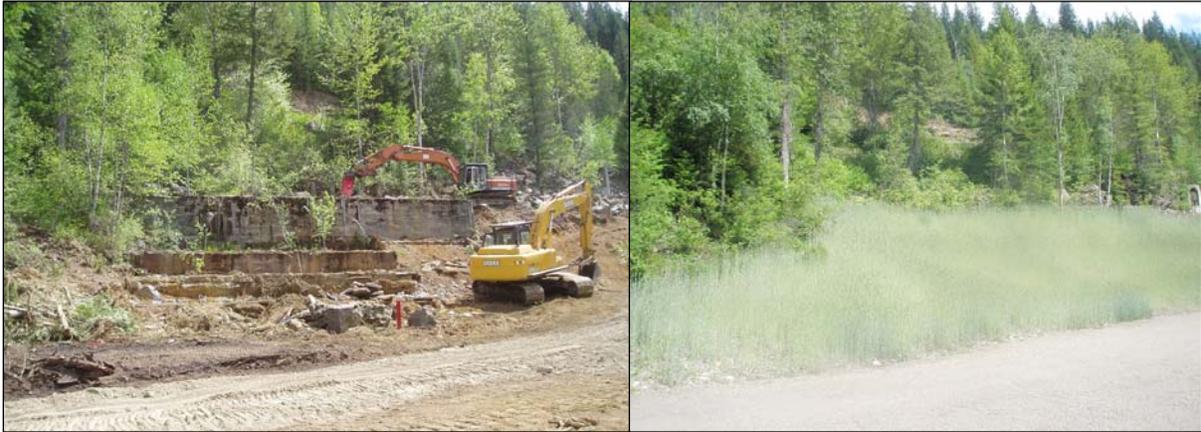
Mill Area before (left) and after (right) remediation.

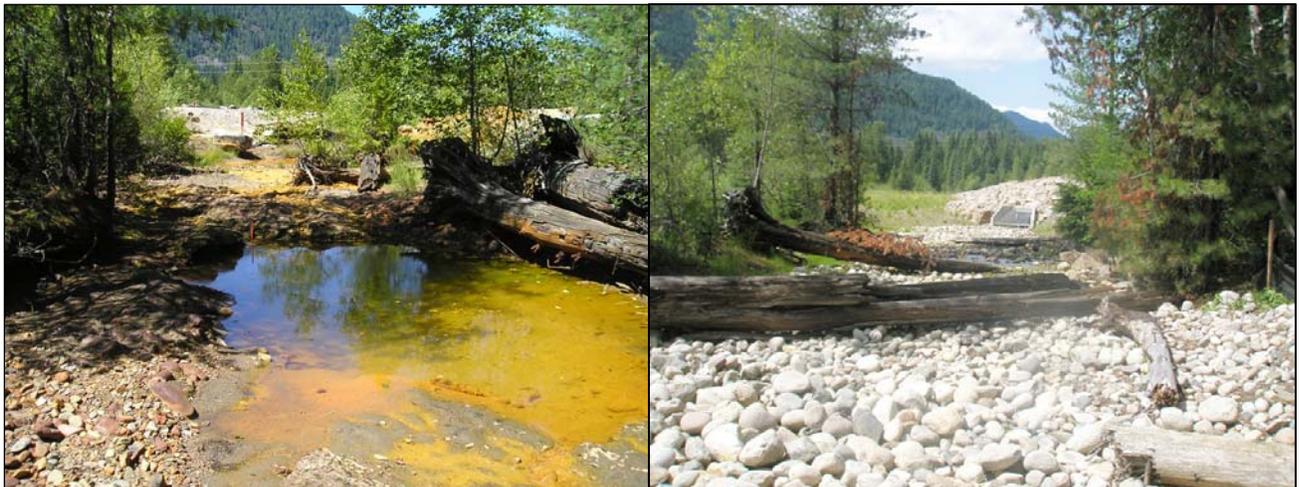
Old Side Channel before (left) and after (right) remediation.
